YARUMO BLANCO VIADUCT.

**CORDILLERA CENTRAL.
COLOMBIA.
2021.**

The La Herradura Viaduct is located on the road that crosses the Central Mountain Range of Colombia to communicate Calarcá and Cajamarca. It is a structure whose works began more than ten years ago and that for various unfortunate circumstances had to be paralyzed -like the rest of the actions of the road of which it was part- leaving the viaduct only partially built.

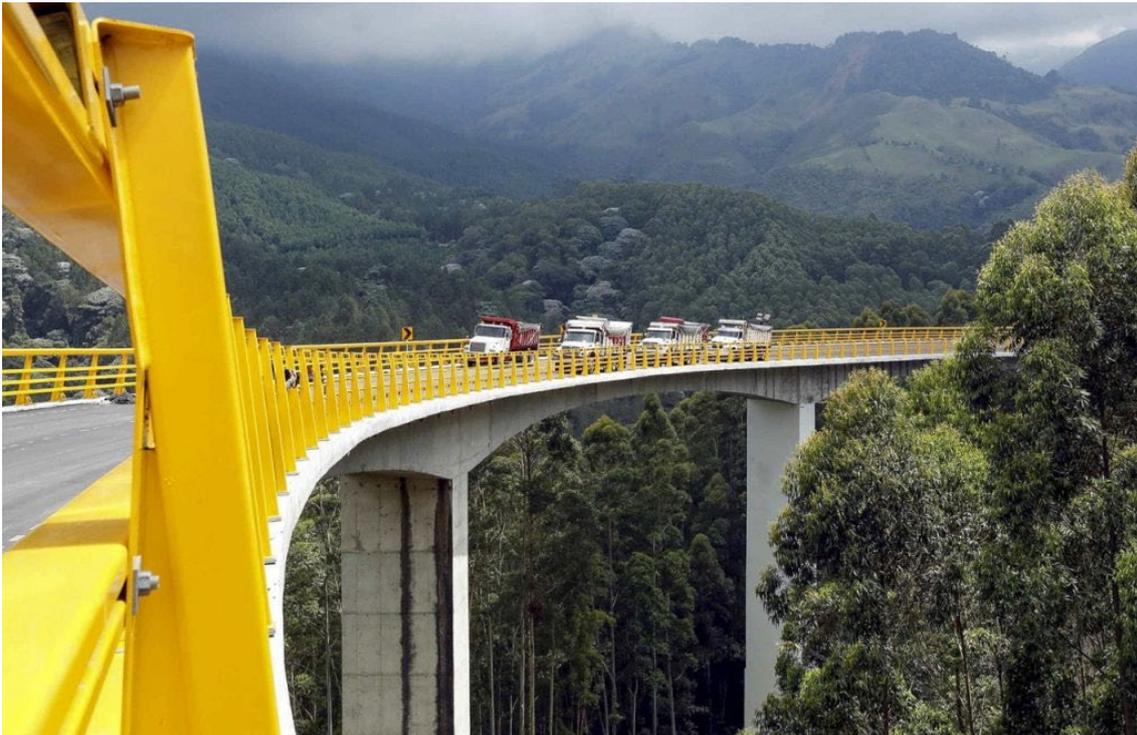
The name of the viaduct comes from its particular geometry as the whole work is in a strongly curved section in plan. The total length of the structure is 640 m, divided into two independent sections by a joint at approximately half the length on axis called 6 resulting in two structures of 300 m (axes 1 to 6) and 340 m (axes 6 to 12). The first section has a distribution of five spans of spans 37.5m-3x75 m-37.5 m. The second presents 6 with lights 34m-3x68 m-34 m).

The deck is a longitudinally constructed prestressed concrete caisson section built by cantilever advance. It has a width of 11.30 m wide, and variable edge between 2.00 in key and 4.20 m on piles with vertical souls.

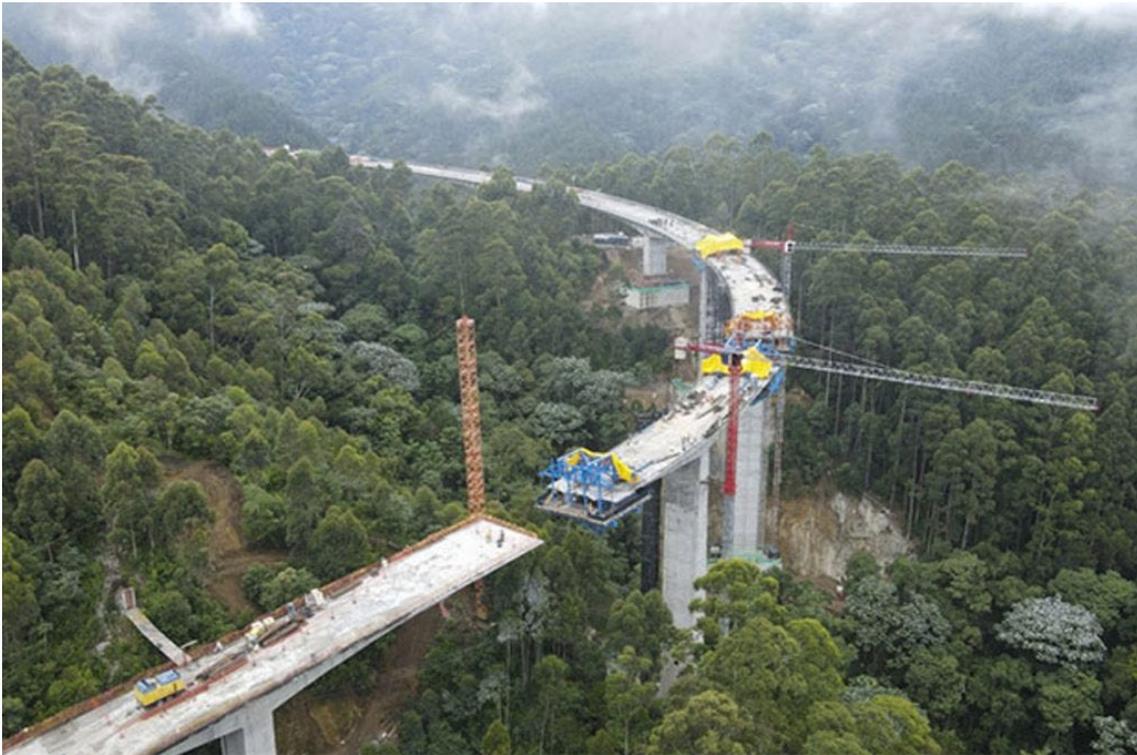
The work was partially executed. Superstructure and substructure completely between axes 6 and 12, and only the substructure as well as some sections of the deck between axes 1 and 6. The foundations were made on "caissons" (wells) of variable depths, many of them executed halfway up the slope in areas of steep slopes. The pillars were made of reinforced concrete with rectangular section of variable dimensions with height.
